**BIG TUJUNGA WASH  
MITIGATION BANK  
FINAL ANNUAL REPORT – 2005**

**LOS ANGELES COUNTY DEPARTMENT OF PUBLIC WORKS  
900 South Fremont Avenue  
Alhambra, California 91803-1331  
(626) 455-6138**

**CHAMBERS GROUP, INC.  
17671 Cowan Avenue, Suite 100  
Irvine, California 92614  
(949) 261-5414**

**April 2006**

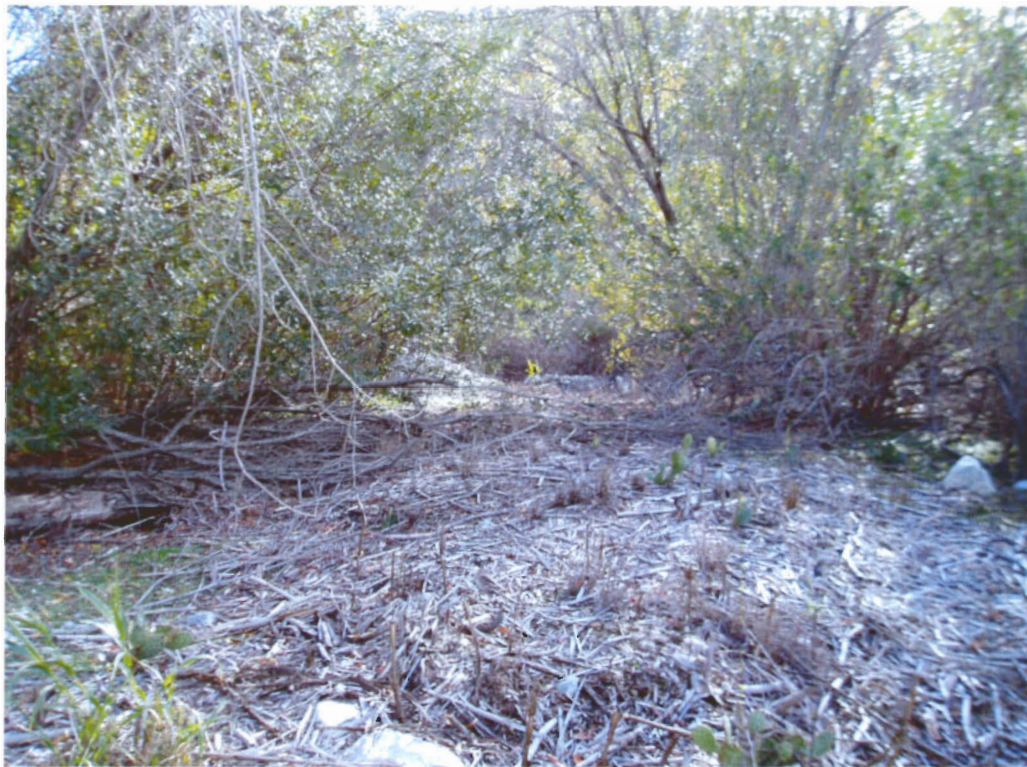
**Photo 23. Area 23, Section 4, taken in November 2004. This area was not located in 2005 due to flood damage.**

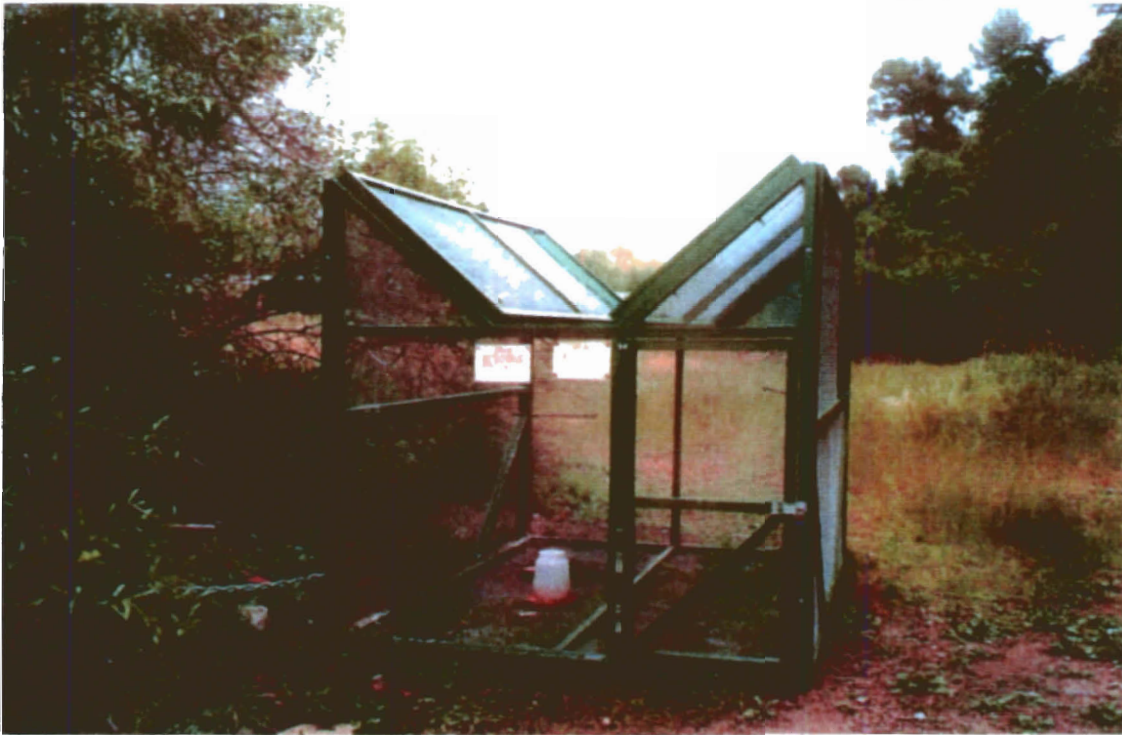
Representative brown-headed cowbird trap from the 2001 trapping season.

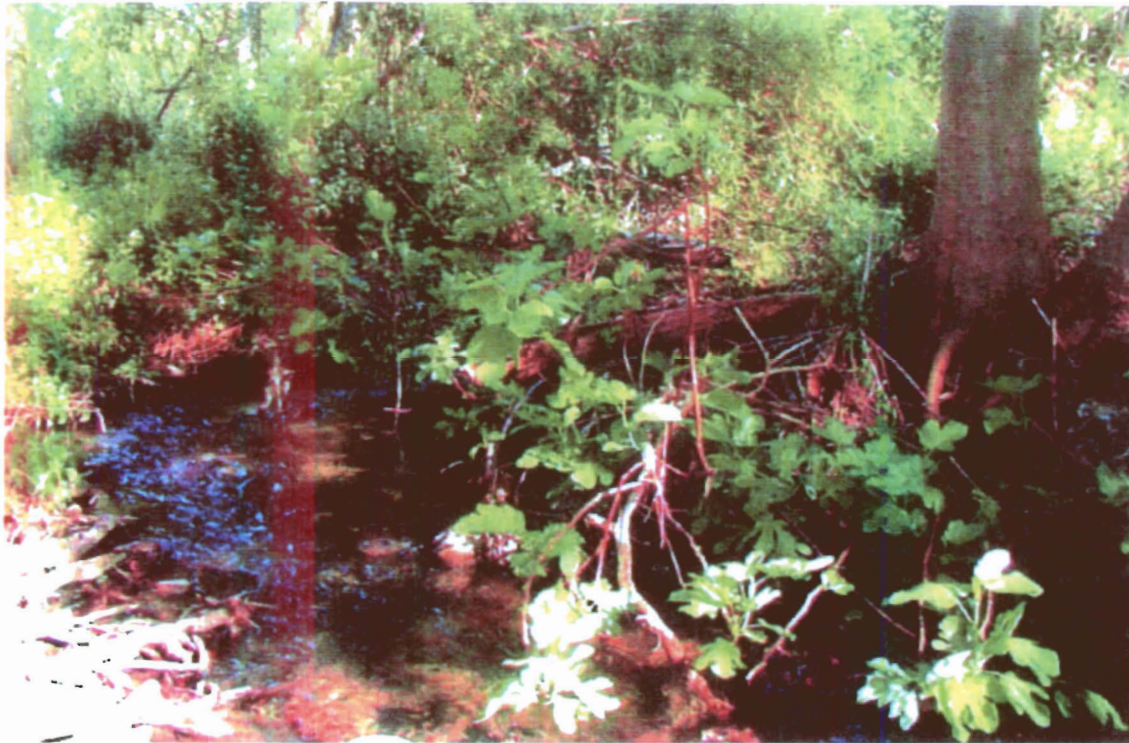
Photo 1. View of the densely vegetated channel located along the southern portion of the project site. No arroyo toad habitat is located within this channel.

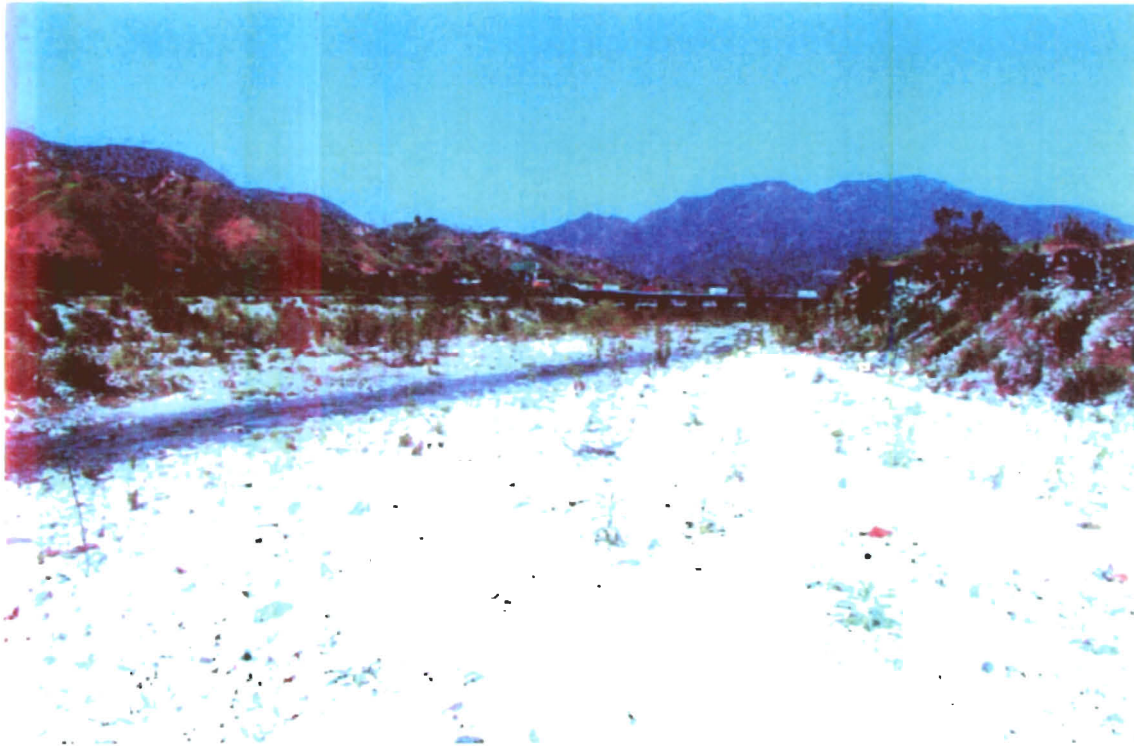
Photo 3. View of the western portion of the survey area, looking east. This site contains mainly cobbles with little sand.
